# CCTV Survey Report

Site  
**Friar Lettings**  
**78 Vartry Road**  
**London**

**78 Vartry Road N15 6PU - CCTV Survey Report : 15/01/24**

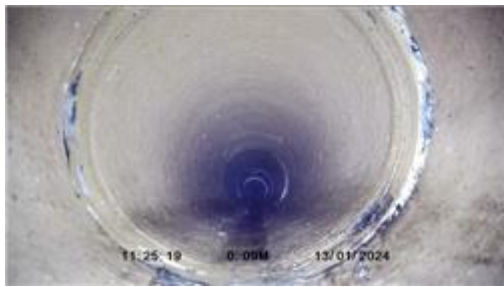
Pos	Video Ref	Code	Description	Image
00.00m		MH	Start node type, manhole MH01	
00.00m	0:00:00	WL	Water level: 0% Height/Diameter	
00.09m	0:00:24	CC	Crack, circumferential from 12 o'clock to 12 o'clock - Severity 1	Image Provided - Ref: 0_2

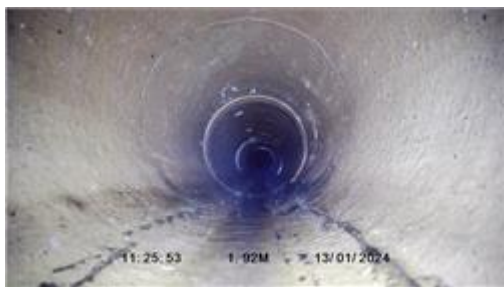
01.90m	0:00:58	CC	Crack, circumferential from 12 o'clock to 12 o'clock - Severity 1	Image Provided - Ref: 0_3

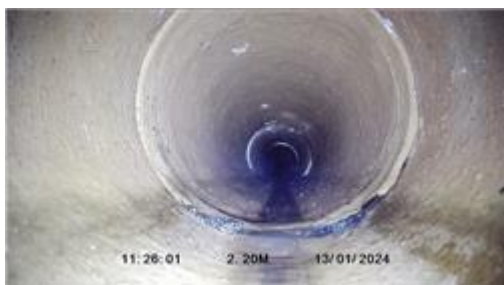
02.20m	0:01:06	CC	Crack, circumferential from 12 o'clock to 06 o'clock - Severity 1	Image Provided - Ref: 0_4

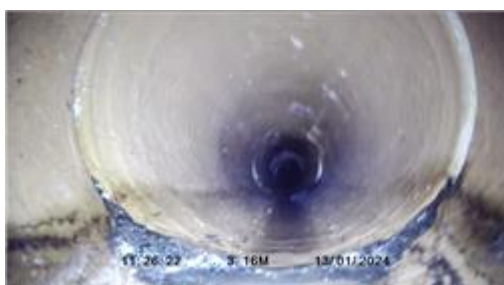
03.16m	0:01:27	DEE	Attached deposits, encrustation from 04 o'clock to 08 o'clock: 10% Cross sectional area loss - Severity 3 Build up of scale.	Image Provided - Ref: 0_5

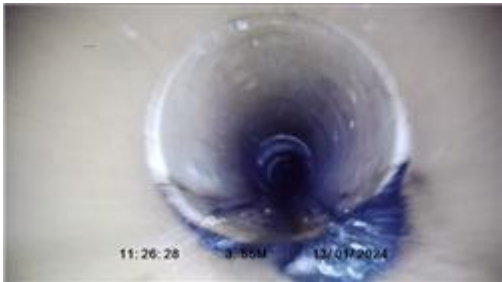
Pos	Video Ref	Code	Description	Image
03.55m	0:01:33	DEE	Attached deposits, encrustation from 03 o'clock to 06 o'clock: 20% Cross sectional area loss - Severity 3	<p>Image Provided - Ref: 0_6</p>

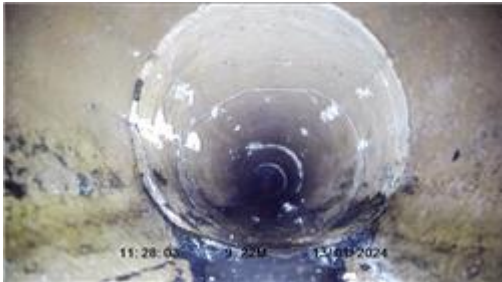
09.22m	0:03:08	FM	Fracture multiple from 12 o'clock to 12 o'clock - Severity 4	<p>Image Provided - Ref: 0_7</p>

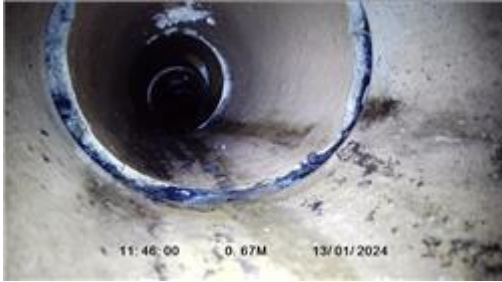
00.67m	0:00:22	OJM	Open joint medium - Severity 3	Image Provided - Ref: 1_3

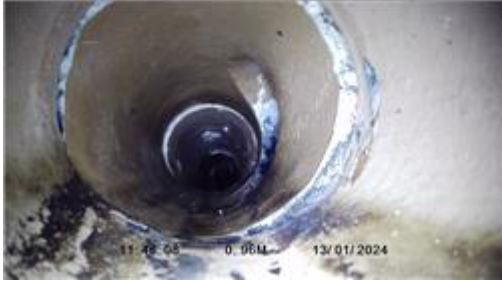
00.96m	0:00:29	OJL	Open joint large - Severity 4	Image Provided - Ref: 1_4

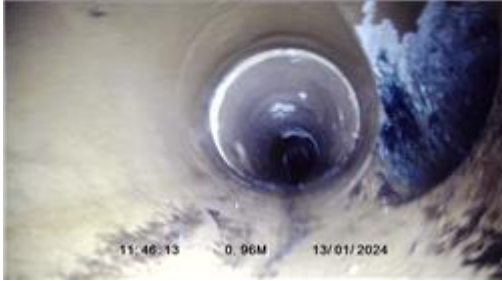
01.00m	0:00:34	JN	Junction at 03 o'clock: 150mm Diameter	Image Provided - Ref: 1_5

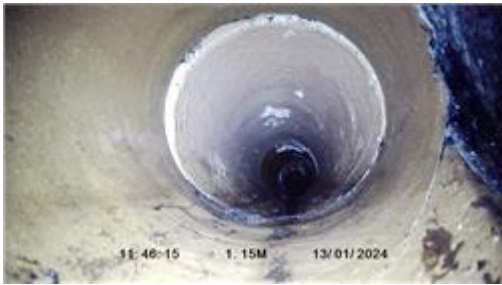
Pos	Video Ref	Code	Description	Image
01.00m	0:00:37	CC	Crack, circumferential from 03 o'clock to 06 o'clock - Severity 1 CRACK ON JUNCTION	Image Provided - Ref: 1_6

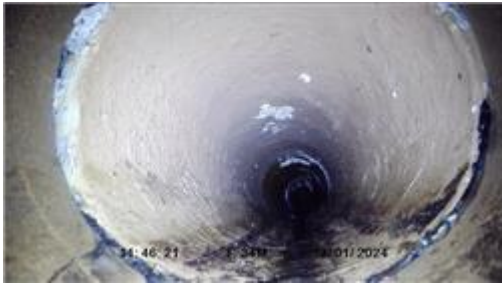
01.34m	0:00:43	CM	Cracks, multiple from 03 o'clock to 07 o'clock - Severity 2	Image Provided - Ref: 1_7

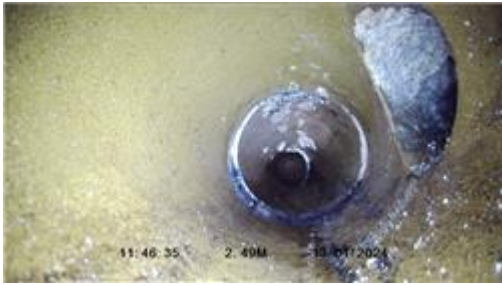
02.49m	0:00:57	JN	Junction at 02 o'clock: 100mm Diameter	Image Provided - Ref: 1_8

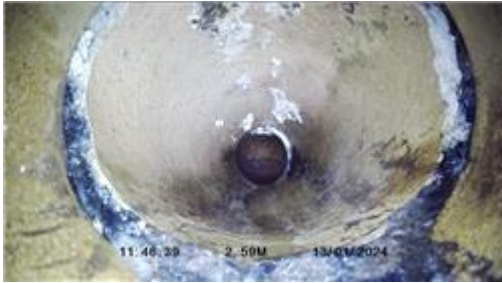
02.59m	0:01:00	OJM	Open joint medium - Severity 3	Image Provided - Ref: 1_9

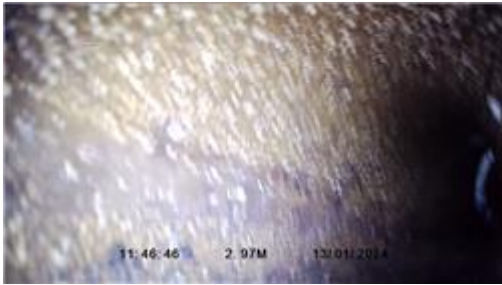
02.97m	0:01:07	LRF	Line of drain/sewer deviates right [full]	Image Provided - Ref: 1_10

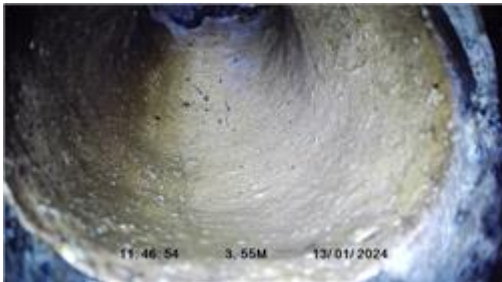
Pos	Video Ref	Code	Description	Image
03.55m	0:01:15	LUF	Line of drain/sewer deviates up [full]	<p>Image Provided - Ref: 1_11</p>
